Asahi India Glass Limited

- Kaizen Theme: To Eliminate the rejection (CULLET MARK) on I-94
- Month of Implementation :- June 2024

## PROBLEM: Glass breakage issue due to Glass position change & causing CULLET MARK issue.

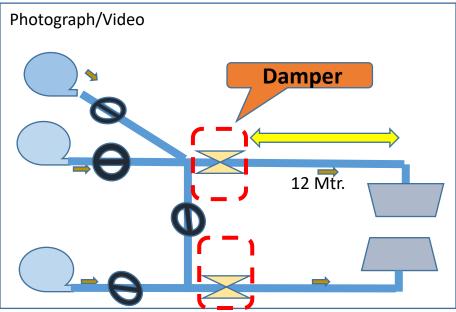
Why 1	Why the Glas	Why the Glass breakage happed at quenching ?											
Ans. 1	Because hit with hard site of blast head .												
Why 2	Why glass hit	Why glass hit with hard site of blast head ?											
Ans. 2	Because glass	Because glass position shift while glass lift up by bottom B/H .											
Why 3	Why glass pos	Why glass position shift while glass lift up by bottom B/H ?											
Ans. 3	Because air fl	ows continuously from upper blast	head .										
Why 4	Why air flows	Why air flows continuously from upper blast head ?											
Ans. 4	Because blower damper install much far .												
ROOT CAU	ROOT CAUSE: Damper position far from blast head . Cause												
ROOT C	ROOT CAUSE - 01 SUGGESTED ACTIONS REMARKS

#### **Before status:**

Previously damper location was at 12 meter distance so glass rotate in B/H

➤ Now damper position changed from 12 meter to 1.5 meter and now no glass position changes

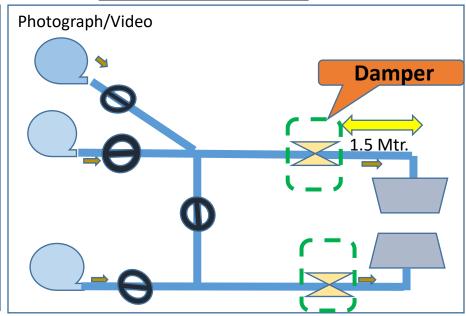
#### After status:

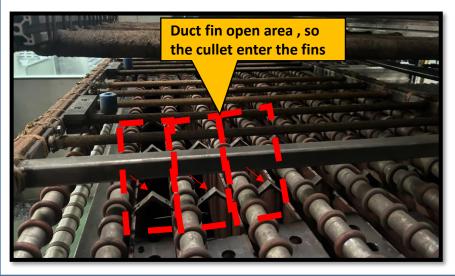
Ans. 1	Breakage cullet particles hitting the glass.									
Why. 2	Why Breakage cullet particles hitting the glass?									
Ans. 2	Because Blow off duct sending the cullet particles on glass.									
Why 3	Why Blow off duct sending the cullet particles on glass?									
Ans. 3	Because there were cullet particles present inside blow off fins.									
Why .4	Why there were cullet particles present inside blow off fins?									
Ans.4	Because blow off fins are open.  Root									
ROOT CAUSE:- Because blow off fins are open.

Design weakness in Blow off duct Cullet blow up & hit with glass.

#### Before status:

Earlier at I-94 blow off station, Cullet enters the blow off fins as no coverage provided.

Now we have added mesh (Mesh Size- 4X4 mm) over the fins to stop cullet entry into the fins of Blow off duct.

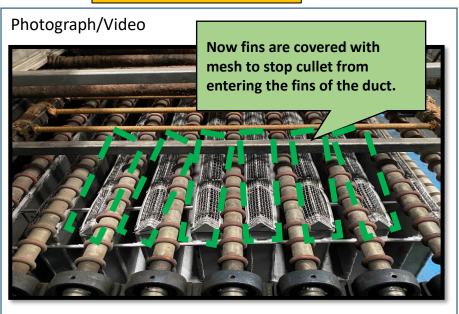
#### After status:

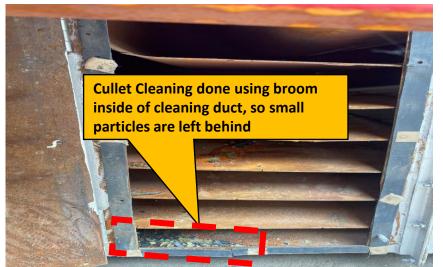
#### **Before status:**

➤ Earlier at I-94 Cullet Cleaning done using broom inside of cleaning duct, so small particles are left behind

Now we have provided Tray for collection of cullet & cleaning.

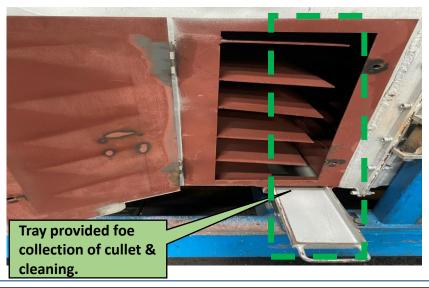
#### After status:
