# JK TYRE & INDUSTRIES LIMITED

## UDGHOSH QUALITY CIRCLE WELCOMES YOU

Banmore Tyre Plant

“Output target not met in Tyre Uniformity machine ”

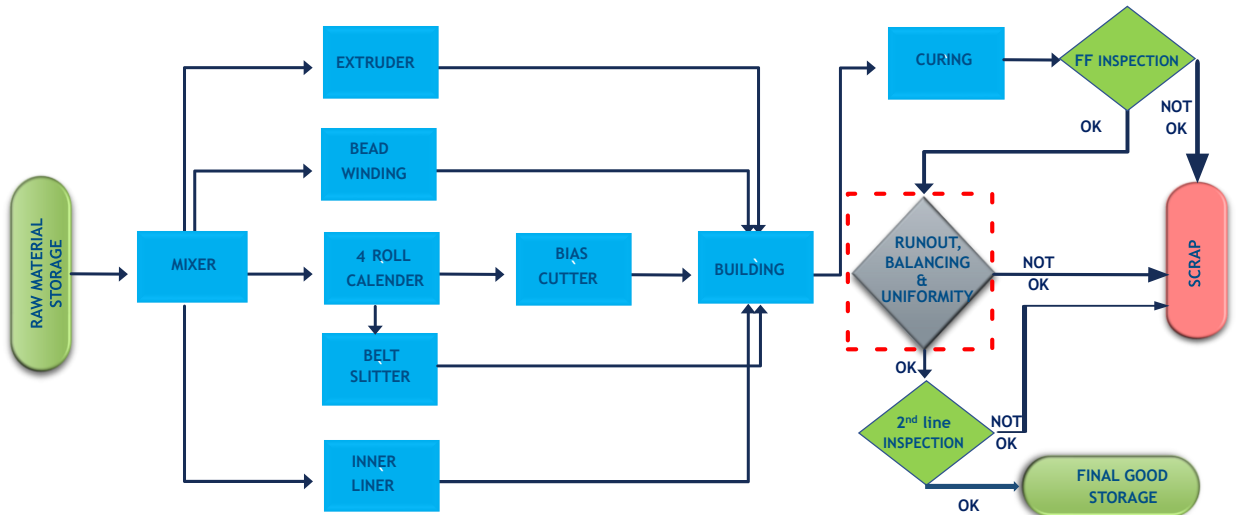
Area under red box is our pain area with problem of "Output target not met in Tyre Uniformity Machine".

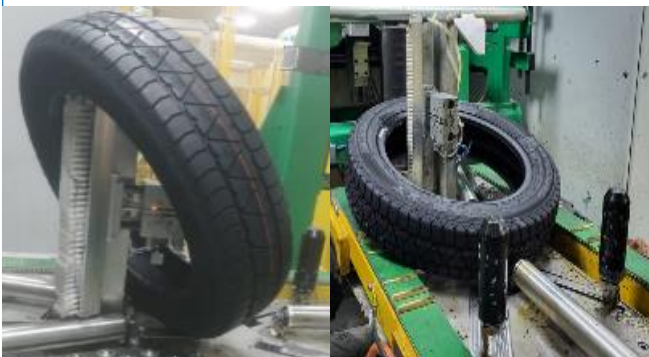
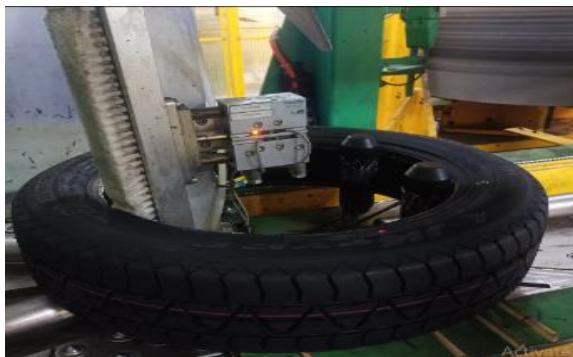
The tyre is very flexible & it is frequently getting stuck in to the conveyor so the speed of conveyor reduced to 50%.

Adjust the conveyer width & run with 100% speed

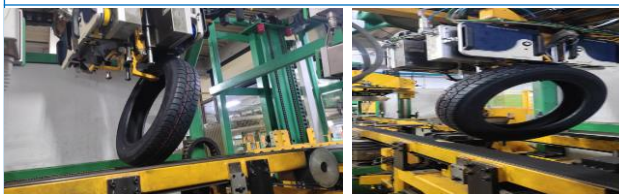
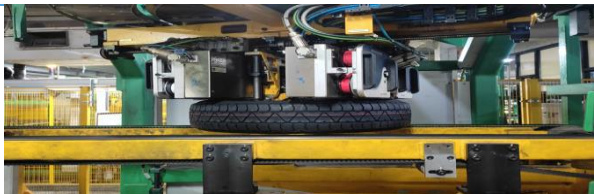
Below 145 mm of tread width marking clamp goes below bottom bead.

Set the tread width 162 mm at M- Conf program
