# Injection Department Presenting Our Quality Circle

## Moriroku Technology India Pvt. Ltd. :

# PROBLEM (THEME) SELECTED

TO REDUCE INTERNAL REJECTION IN GARN RR  
BPR (3US) .

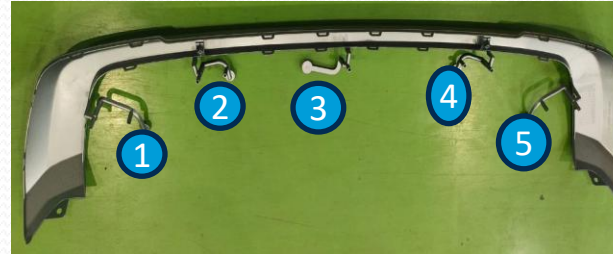
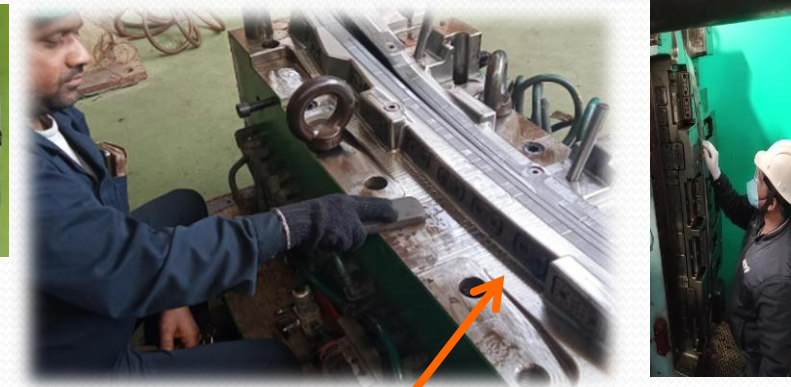
- 1 **Why** Flow Mark problem in Part?  
Due to Air decompress in mould during part filling
- 2 **Why** Air decompress in mould?  
Cavity air is not released from mould
- 3 **Why** cavity air not release from mould?  
Air vent not clean properly.
- 4 **Why** Air vent not clean?  
Air vent blocked rapidly due to more fumes generated in mould
- 5 **Why** more fumes generated?  
High fumes due to special raw materials; existing air vent cleaning is insufficient.

Air vent cleaning by tool room person

Air vent found blocked

- ☐ Air vent cleaning frequency increase three month to one month.
- ☐ Air vent cleaning Points added in PM Check Sheet .

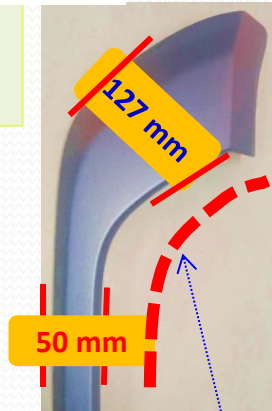
Where is flow mark generated?  
Flow mark generated at curve area due  
material property.

Why generated in curve area?  
Melted material flow not smooth

Why material not flow smooth ?  
Mold radius not supported at curve

Why radius not supported?  
Radius inadequate at curve area.

Material friction during injection

Curve area part  
width excessive.

Before Gate size 13.5 mm

Gate size increase 2mm

\* The middle gate (no -03) size increased by 2 mm  
from 13.5mm to 15.5mm

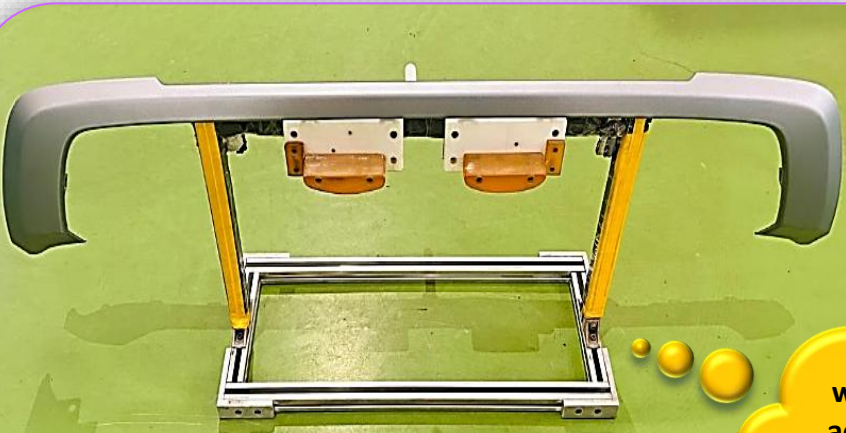
**Part inspection  
with the help of an  
actual car condition  
inspection jig,  
manufactured in-  
house by us.**

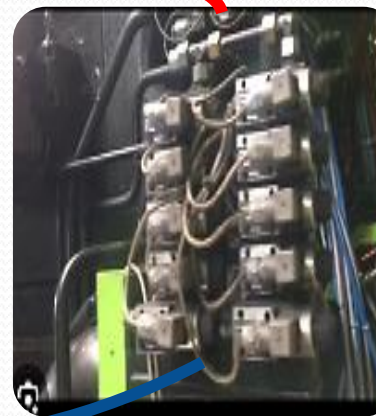
MOULD WITH SEQUENTIAL  
VALVE

TIMER.

ONLY 4 KG AIR PRESSURE  
RECEIVED.

Pin back completely

MATERIAL FRICTION  
GENERATED DUE TO  
SEQUENTIAL PIN NOT MOVE IN  
BACK DIRECTION INSIDE THE  
MOULD DURING INJECTION.

SEQUENTIAL PIN

□ We install additional AIR BOOSTER to increase the air pressure for the proper movement of sequential valve ga

AIR  
COMPRESSORAIR BOOSTER  
ADDED

AFTER USE OF AIR BOOSTER  
AIR PRESSURE INCREASE UP  
TO 5 KG.

SEQUENTIAL PIN MOVE IN  
BACK DIRECTION  
COMPLETELY AND REDUCE  
MATERIAL FRICTION  
PROBLEM.
