QC TEAM NAME : PRAYAS QUALITY CIRCLE

PROJECT TITLE : TO ELIMINATE LOW INTENSITY IN TSV STI (SIDE TURN INDICATOR) LAMP

COMPANY NAME : SMR AUTOMOTIVE SYSTEMS INDIA LIMITED

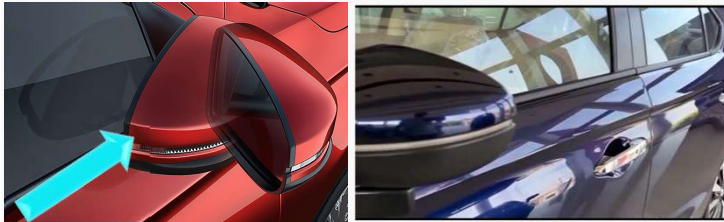
### What is STI ?

- Side turn indicators, also known as side turn signals or blinkers, are an essential safety feature in modern vehicles. These small but vital components play a crucial role in ensuring safe driving by alerting other drivers of your intent to turn or change lanes. Understanding the function, application, and importance of side turn indicators can help drivers navigate the roads more safely and prevent accidents.

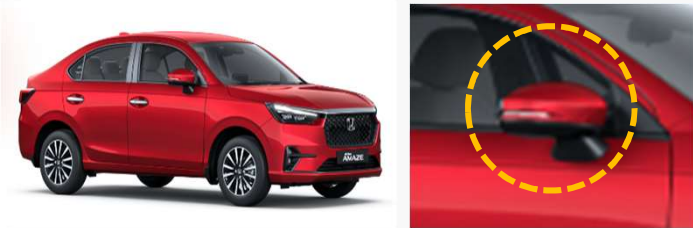
### Application of Side Turn Indicator ?

- Side turn indicators are typically mounted on the side mirrors or fenders of a vehicle and are an integral part of the overall lighting system. They are used whenever a driver needs to indicate a change in direction, such as turning, changing lanes, or merging into traffic.

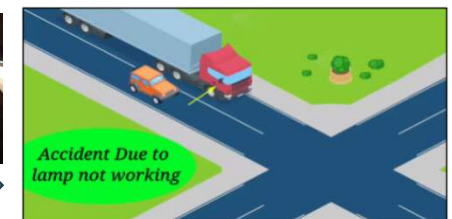
What is impact on Vehicle?

- If there will be low intensity on parts than there is chance that Indicator aesthetic will get affected . If the side turn indicator does not give complete intensity, it can lead to confusion and hazardous situations on the road. Other drivers may not be aware of your intent to turn or change lanes, increasing the risk of collisions and accidents. Proper functioning of the side turn indicator is essential for safe driving and maintaining situational awareness on the road.

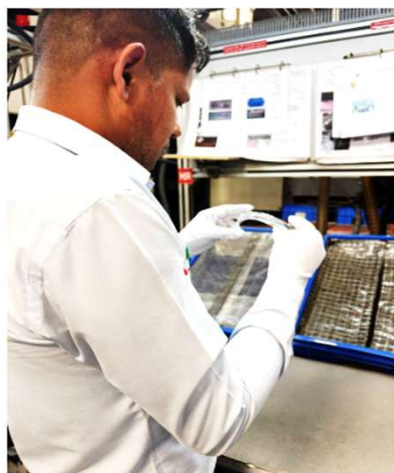
| What | When | Where | Who | How |
| Inspection Method | 21.06.2025 | Inspection Area | Sumit | NG & OK Part verification |

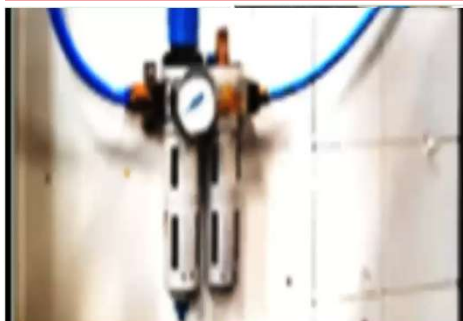
✓ Earlier there was issue due to system air pressure was on its peak and some time was getting drop so that solenoid was not opening fully and injection pressure was getting drop.

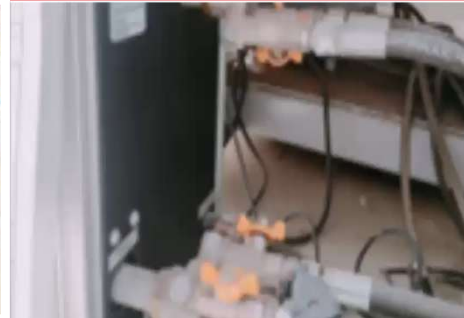
✓ There was no LPM (Liters Per Minute) monitoring available on the machine. As a result, any partial blockage in the cooling system affected the water flow.

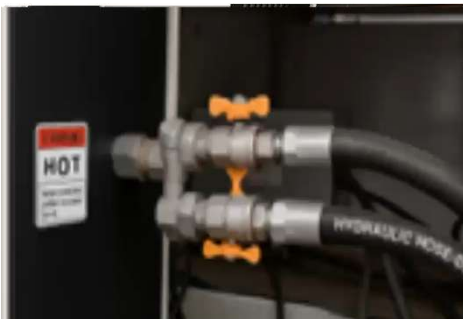
- ✓ There was issue of partial cooling line blockage due to small size of pipelines.

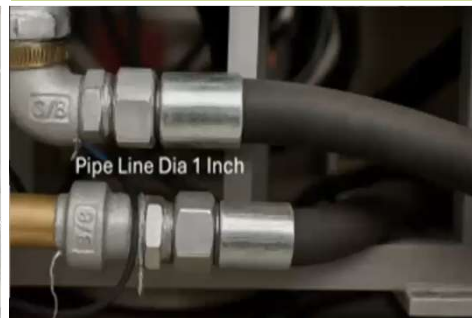
- ✓ One inch pipeline added in place of old-line pipeline (3/8 Inch). So it is providing efficient cooling and not getting blockage.

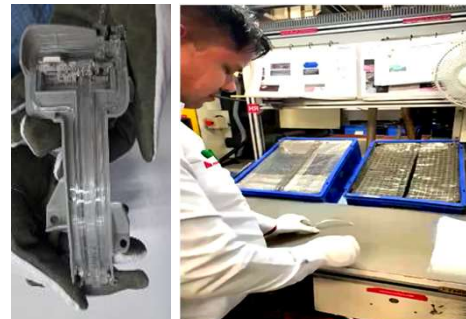
- ✓ Earlier there were visual inspection so defect were skipping from molding to next process.

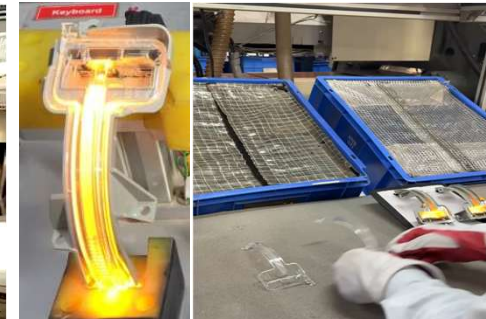
- ✓ Glowing inspection started to detect defect at Molding stage only.
