Asahi India Glass Limited

- Kaizen Theme: To Eliminate the rejection (CULLET MARK) on I-94
- Month of Implementation :- June 2024

## PROBLEM: Glass breakage issue due to Glass position change & causing CULLET MARK issue.

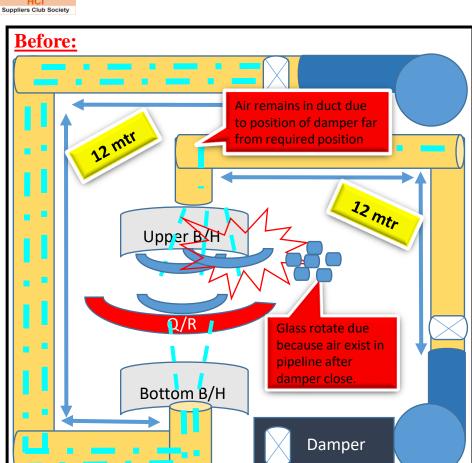
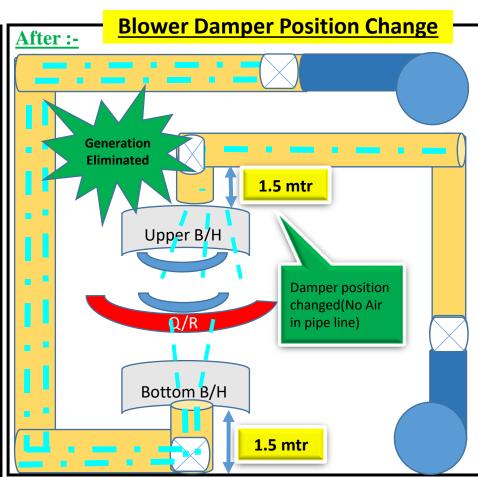
**KAIZEN NO.:-01**

Ans. 1	Breakage cullet particles hitting the glass.									
Why. 2	Why Breakage cullet particles hitting the glass?									
Ans. 2	Because Blow off duct sending the cullet particles on glass.									
Why 3	Why Blow off duct sending the cullet particles on glass?									
Ans. 3	Because there were cullet particles present inside blow off fins.									
Why .4	Why there were cullet particles present inside blow off fins?									
Ans.4	Because blow off fins are open.  Root									
ROOT CAUSE:- Because blow off fins are open.

ROOT CAUSE 01	Suggested action	REMARKS	
Blow off duct fins	Reduce the Blow off Pressure	Cannot meet the glass blow up properly.	
are open	Provide mesh on the fins of Blow off Duct	Accepted	•
