# Injection Department Presenting Our Quality Circle

## Moriroku Technology India Pvt. Ltd. :

# PROBLEM (THEME) SELECTED

TO REDUCE INTERNAL REJECTION IN GARN RR  
BPR (3US) .

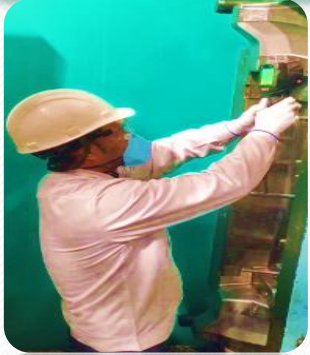
Validate the mold chiller  
temperature & Hot  
runner temperature  
mould temp. is found ok

CHECK MOULD TEMP. WITH THE  
HELP OF THERMAL CAMERA.

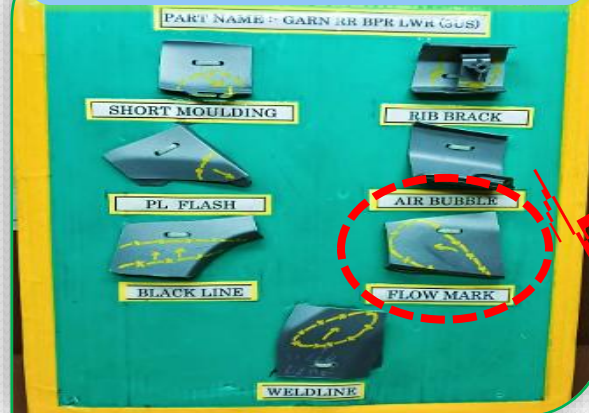
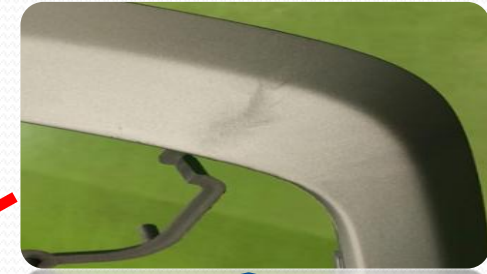
**FLOW MARK PROBLEM  
MENTION IN MOULDING  
PART DEFECT SHEET**

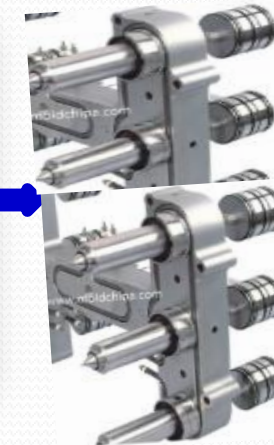
MATERIAL FRICTION  
GENERATED DUE TO  
SEQUENTIAL PIN NOT MOVE IN  
BACK DIRECTION INSIDE THE  
MOULD DURING INJECTION.
